Why Lockedair

Sound Performance Machine

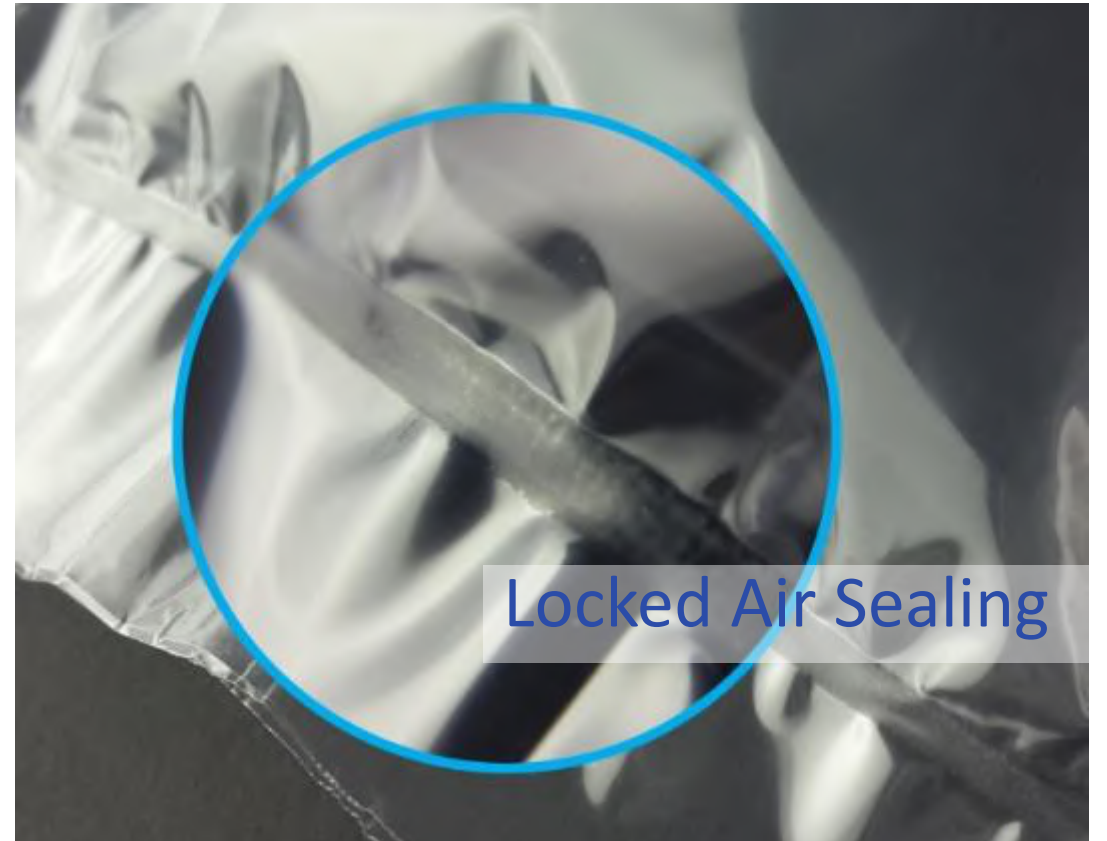
Common Failure

Lockedair's sealing line eliminated wrinkles, or leakage point by well controlled process including film tension, Pre-heat, heat Seal, Cooling down.

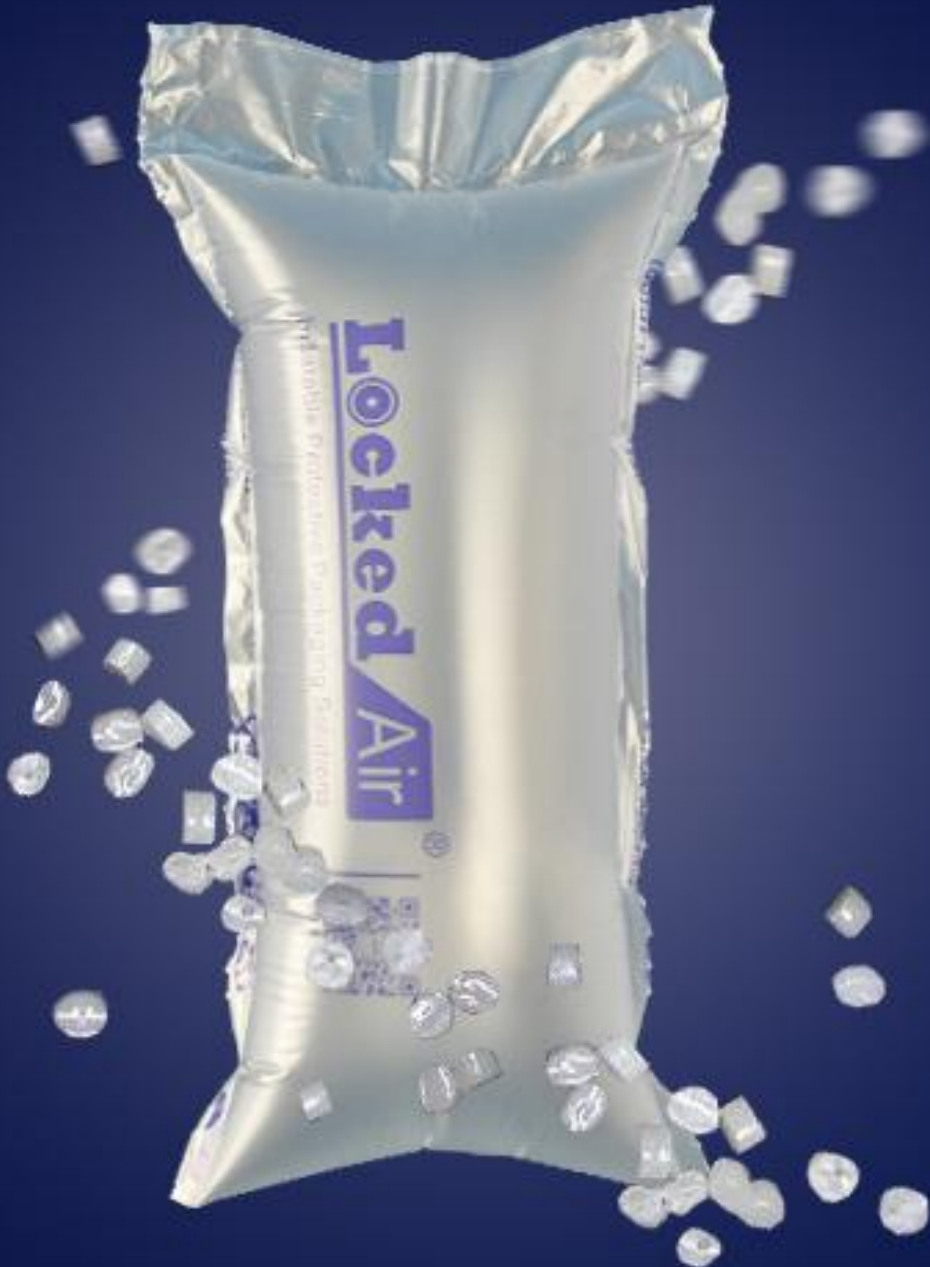
- ① Moderate compression strength (Tensile Strength= 93.4Mpa)
- ② Super resilience.(Puncture Force= 103N/mm)
- ③ High resistance to puncture. (Dart Drop Impact= 350g)
- ④ Stability under the extreme pressure(Tear Strength= 64.5N, Tensile Elongation= 750%)

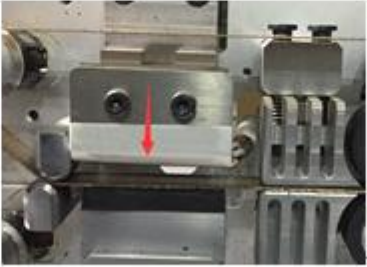
↕	Abnormal Phenomena↕	Possible Reasons↕	Determining Methods↕	Graphical Representation↕	Solutions↕	
					Yes↕	No↕
1.1↕	Air leakage and not sealed tightly	Whether the temperature parameter is excessively low?↕	Gradually turn up the temperature and try once by turning up every 5°C.↕	--↕	Problem solved↕	Jump to next one.↕
		Whether the film is with problems?↕	Change another box of film for testing.↕	--↕	Change the film↕	Jump to next one.↕
		Whether the heating tube is damaged and unable to heat?↕	Start the machine; after heating 1 to 2 minutes, Check whether “heating abnormality” warning emerges.↕	--↕	Jump to 2.1 Heating Tube Abnormity or request for after-sales repair.↕	Jump to next one.↕
		Whether the heating module stops after operation?↕	When the machine heats to the setting temperature and starts to operate, observe the heating module; if its temperature does not drop, the linear motor upgrading is abnormal.↕

Jump to 2.2 Elevating Abnormity of Linear Motor or request for after-sales repair.↕	Deliver to the R&D department for further analysis.↕
